Ultra-Deepwater Production Systems Final Report

Date Report was Issued: August 2005

DOE award number: DE-FC26-00NT40964

**Submitting Organization: ConocoPhillips Company
600 N. Dairy Ashford
Houston, Texas 77079**

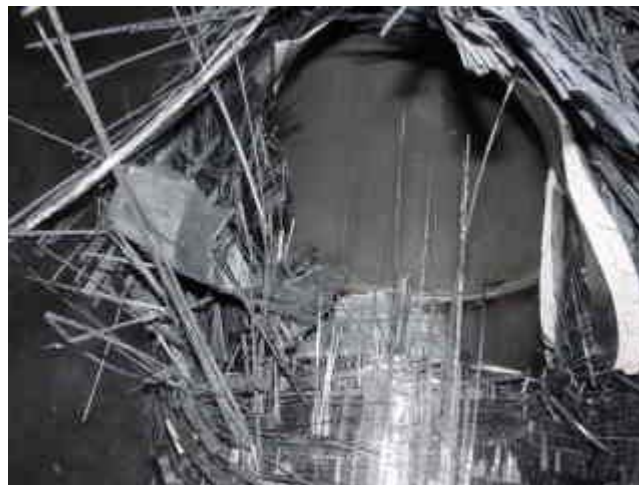
Fig. CPR 7 – CLT-1 Burst Area

The failure appears to have initiated in the vicinity of the MCI/Liner weld, then propagated up the MCI ramp, with the composite failing around that area (Fig. CPR 7). Also notable, is the fact that the sudden depressurization of the bore caused buckling (bulge) of the steel liner, as would be expected.

Even though the failure initiated in the metal part, the composite should have been able to contain the burst stresses, although the cutting action of the metal “lips” along the fracture may have weakened the inner hoop fibers and precipitated the composite failure. Still, this

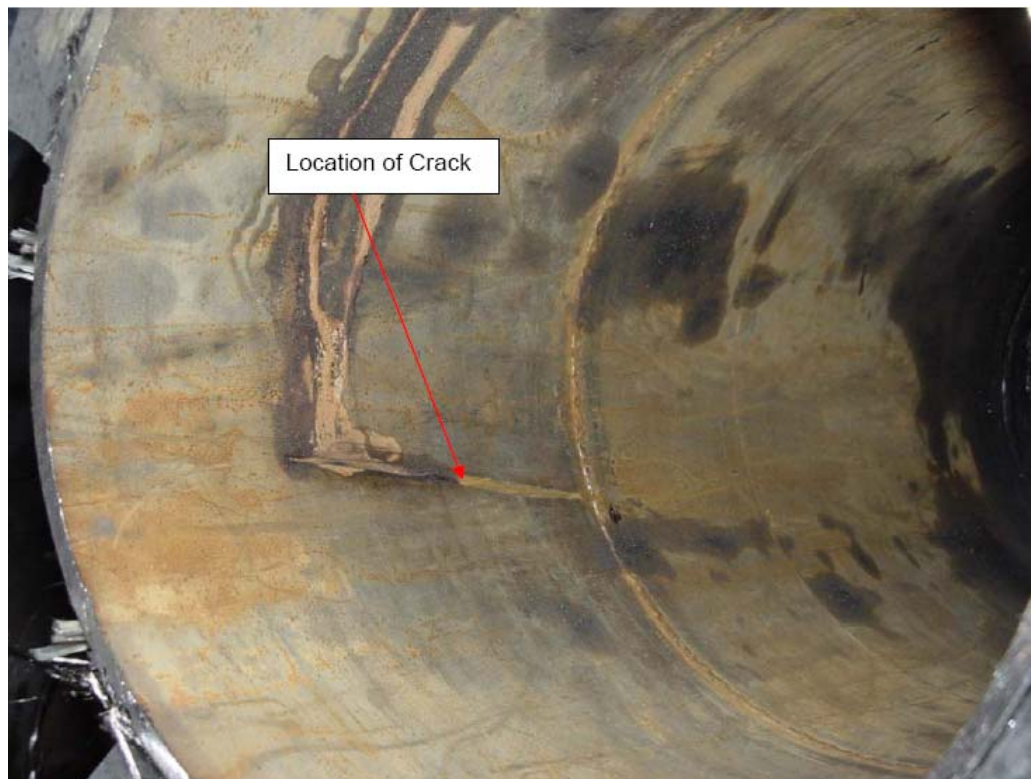
Fig. CPR 8 – Machined Crack in Steel Liner

The sample was subjected to the two FAT pressure cycles without incident. A narrow longitudinal groove was then machined into the steel liner (Fig. CPR 8). The depth of the groove (approx $\frac{3}{4}$ of liner wall thickness) is enough to initiate a full penetration crack at a pressure significantly below the 10,000 psi test pressure called for in the cracked liner testing procedure. The expectation is that the crack will open at the bottom of the machined groove while the sample is going through the next pressurization cycle.

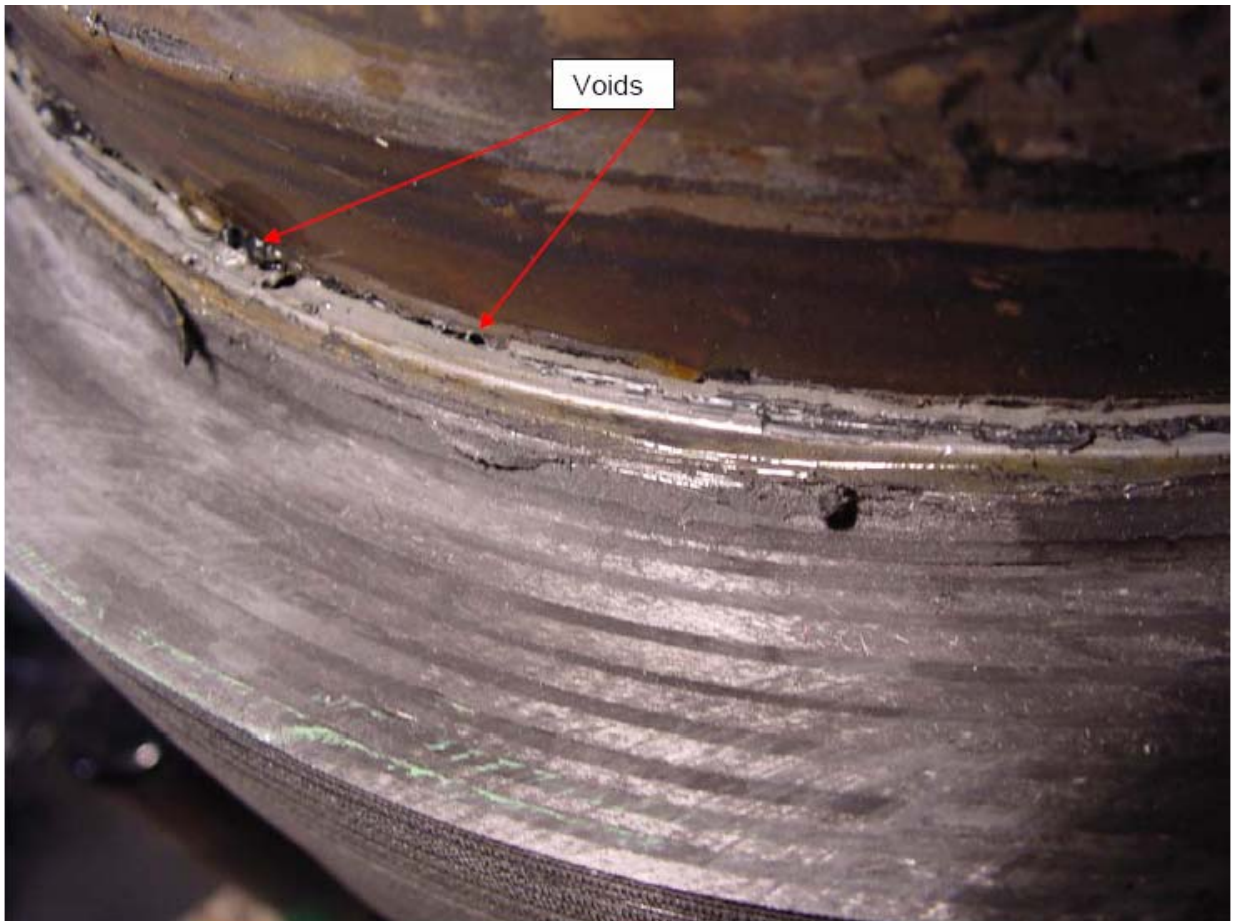
Fig. CPR 11 – Voids in Sealant/Rubber Interface Adjacent to Seal Groove

In CLT-2, it was concluded that the bond between sealant and rubber was defective, with many visible voids (Fig. CPR 11). It should be noted that the leak did not go through the lip seal itself. Another observation was that the inside face of the rubber liner immediately above the liner crack bore an “imprint” of the crack. This was attributed to the jetting action of the water as the crack opened. The rubber was only indented, not penetrated.

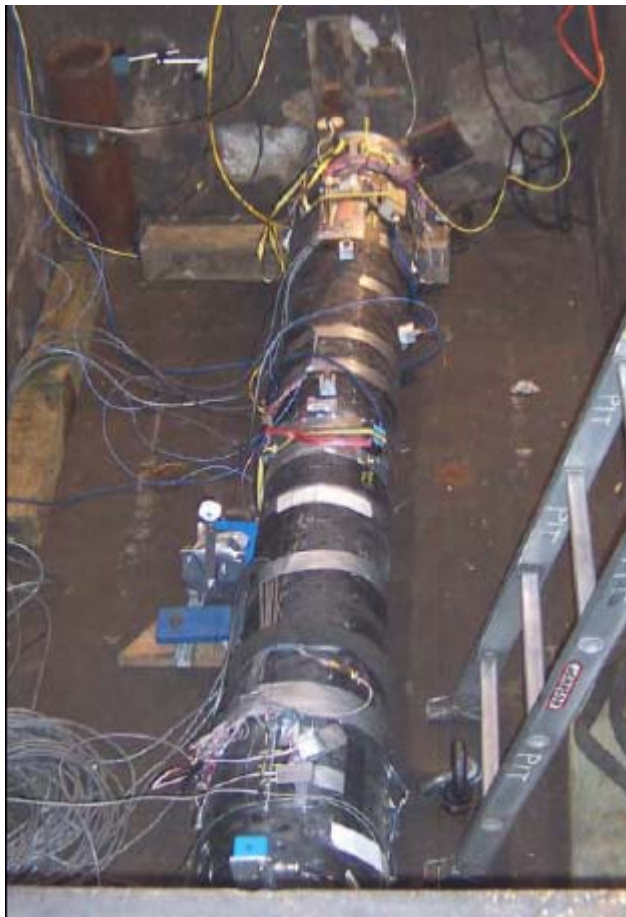
Fig. CPR 17 - TS-2 Test Sample – Before and After Burst Test

TS-2 was selected for the burst test. The joint burst at 20,983 psi in the tube section (Fig. CPR 17), with the steel liner rupture occurring away from any weld.. Although close to the design requirement, this pressure fell substantially short of the FEA prediction.

The TS-2 test result prompted an in-depth review of the FEA. It did not reveal any specific flaw with the analysis itself. However, a visual inspection of the test joint composite cross section showed that, due to the manufacturing process combining pre-impregnated axial strips and filament wound hoop fibers, hoop layers exhibited some variations in thickness (“waviness” – Fig. CPR 18), whereas the model assumed a more regular geometry, as had been achieved on the NIST and Heidrun projects, where helical filament wound fibers had been used instead of axial mats. Further analysis determined that the effect of this waviness on the stress distribution was not negligible. This mostly explained the discrepancy between FEA and test. FEA allowable stresses input parameters were subsequently reduced to reflect this situation, resulting in the requirement for additional fibers.

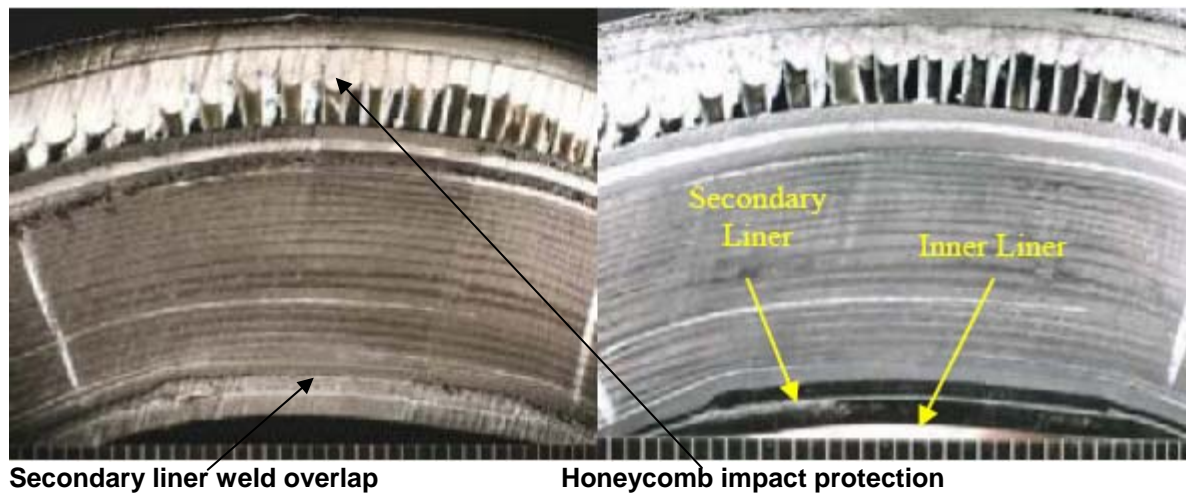
Fig. CPR 20 – TS-4 Section after Burst Test

TS-4 was then taken to a burst test, and failed at 18,404 psi, again less than predicted. The failure occurred away from any primary liner weld and away from the impacted zone. However, the failure line was alongside the secondary liner longitudinal weld overlap. Fig. CPR 20 shows a section of the tube away from the failure area.

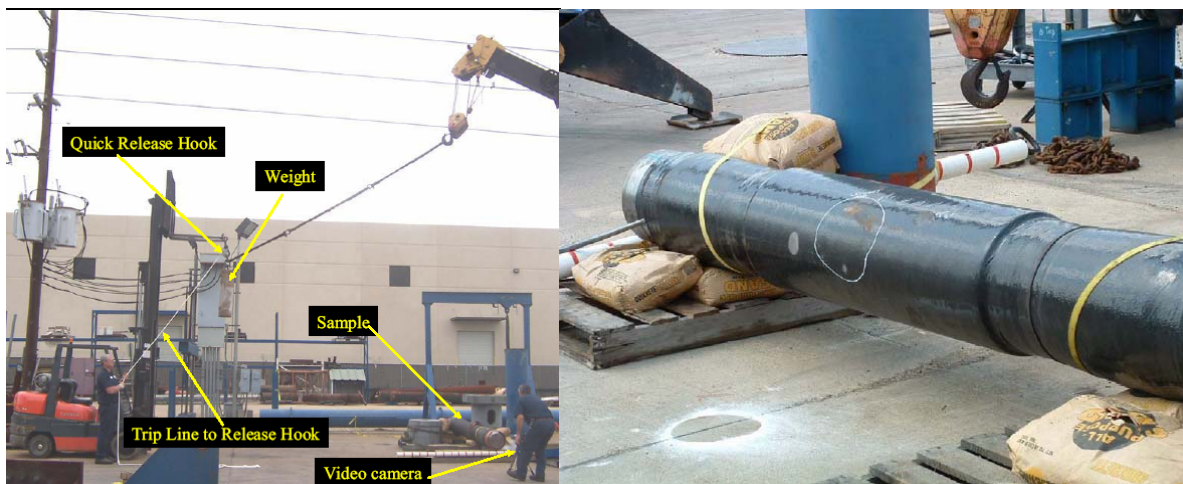
Fig. CPR 21 – TS-5A Impact Test

TS-5A was first impacted at 10 kJ (Fig. CPR 21). Visual examination, including cutting out the section of syntactic foam around the impact area, did not detect any damage. The joint was then burst tested, with ultimate failure occurring at 25,716 psi, satisfying the burst requirement. The DeepWater Composites FEA model had predicted a burst capacity of over 23,644 psi. An independent FEA performed by Grover Engineering Mechanics had corroborated this prediction prior to the test. Again, it should be noted that the failure occurred away from the impacted zone, and away from any inner liner weld. The burst sequence was first rupture of the hoop layers around the tube section, followed by ductile failure of the steel liner.

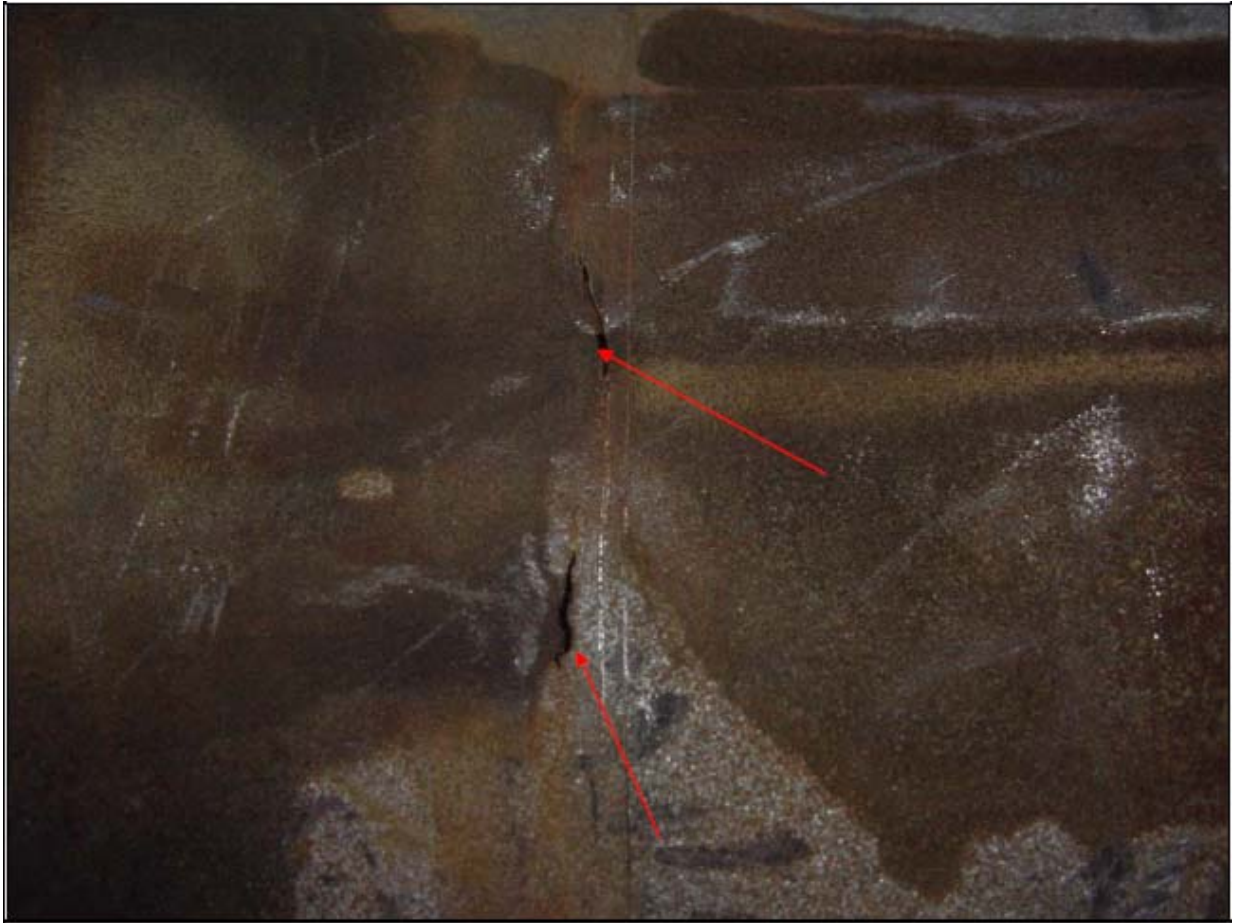
Fig. CPR 30 – Secondary Liner Cracks in CLT-7

The composite around the leaking end of CLT-7 was stripped off for examination. Surprisingly, two full penetration cracks were also found in the secondary liner to MCI weld (Fig. CPR 30). It is not clear whether these cracks opened during the testing or only after releasing the stress from the surrounding composite. Judging by the fact the joint did not leak until after the secondary liner was penetrated, it seems these cracks were still closed at least until that time.

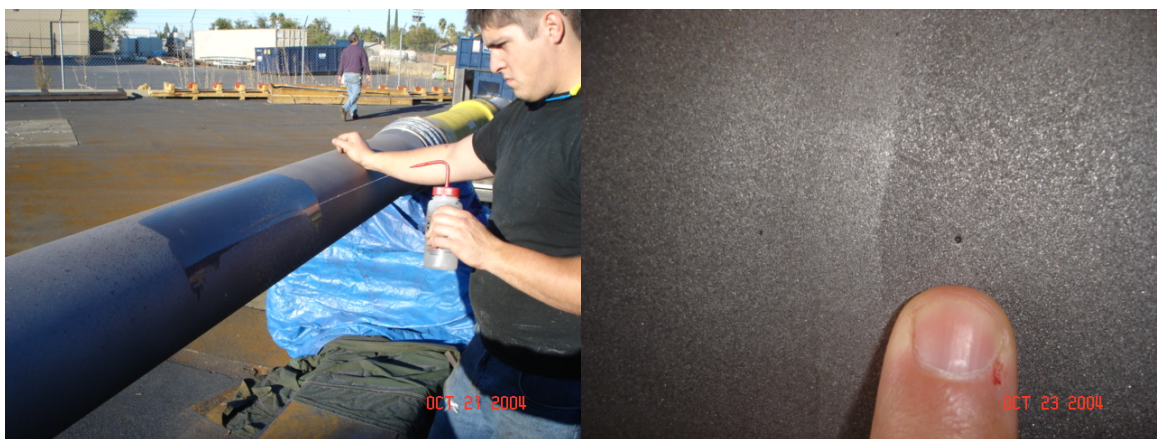
Fig. CPR 39 – Acetone Test (left)/Pin hole in Secondary Liner (right)
